INDOOR AIR QUALITY ASSESSMENT

**Department of Revenue
110 Mulberry Street
Brockton, Massachusetts**

Prepared by:
Massachusetts Department of Public Health
Bureau of Environmental Health Assessment
December, 2000

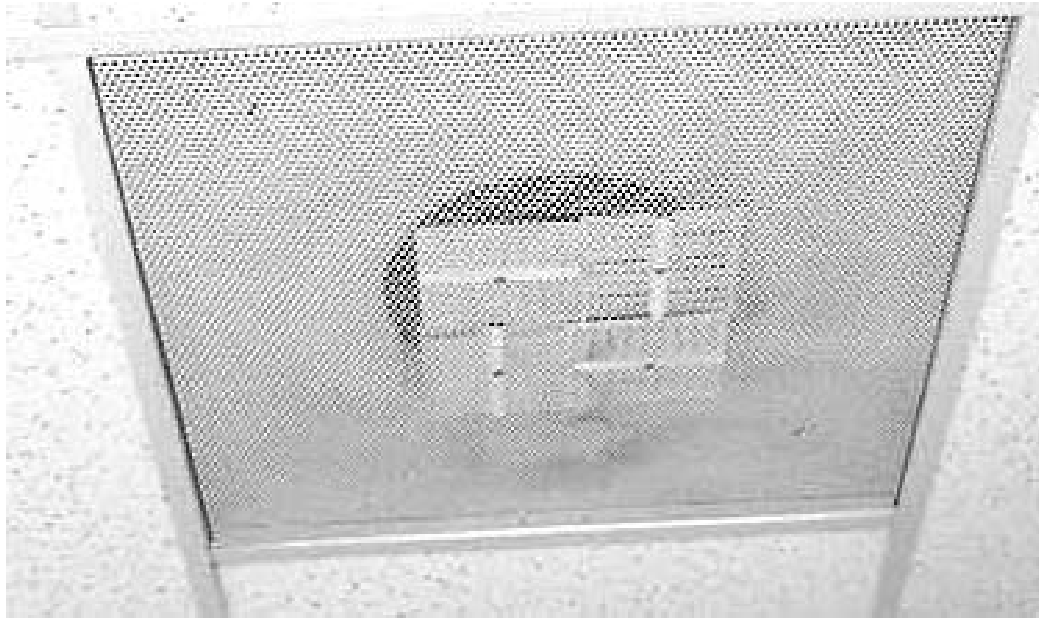
Picture 1

diffusers (see Picture 1). It is important to note that in many instances flexible ductwork was not connected to air diffusers but delivered air directly above them. This configuration (an “open” system) can result in uneven air delivery and can introduce particulates from the ceiling plenum into occupied areas (see Other Concerns).

Example of Multi-Directional Air Diffuser: Note open Ductwork over Diffusers

2. In order to improve indoor air quality, an increase in the percentage of fresh air supply into the HVAC system may be necessary for some areas.
3. Consider replacing existing air diffusers with multi-directional diffusers that connect directly to ductwork (see Picture 19 for an example) forming a “closed” system.

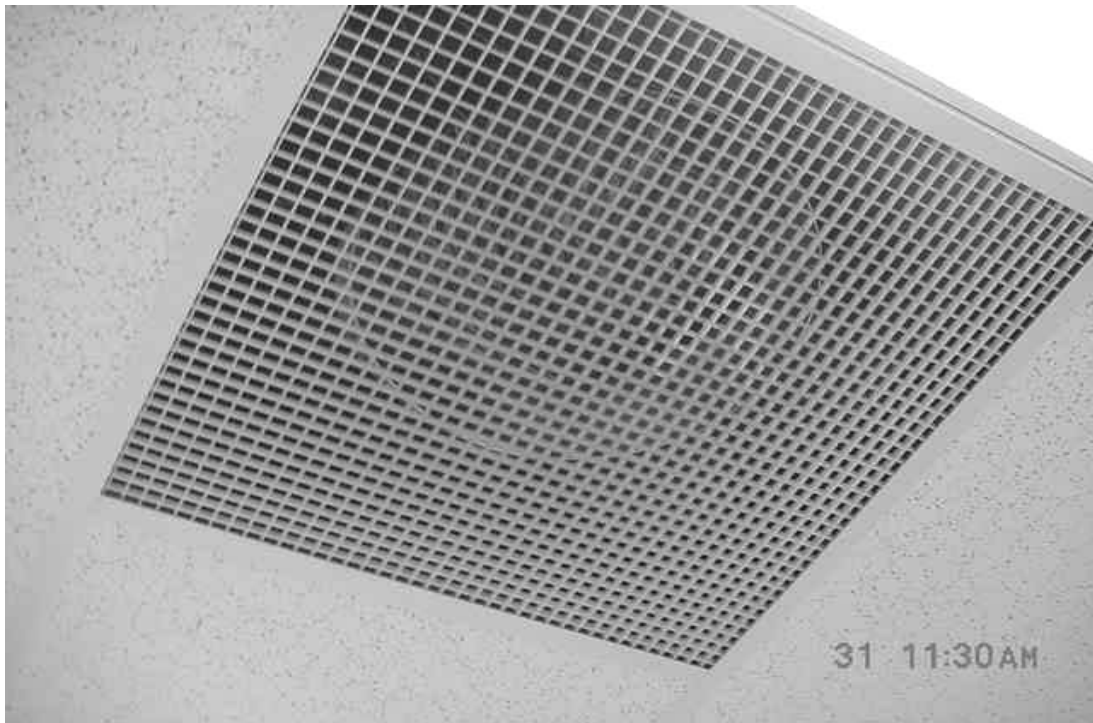
Picture 2

Exhaust ventilation is provided by ceiling-mounted exhaust grilles, which return air to the AHUs via ductwork (see Picture 2). A number of AHUs were in the off cycle during portions of the assessment. DOR personnel reported one of the AHUs was deactivated and was scheduled for replacement. As previously mentioned, a number of windows were open during the assessment allowing the infiltration of hot outside air (background temp 82° F). The infiltration of hot outside air raises interior temperatures, resulting in thermostats deactivating the AHUs. Without operating AHUs, fresh outside air is not distributed via the HVAC system.

Ceiling-Mounted Exhaust Vent/Grill

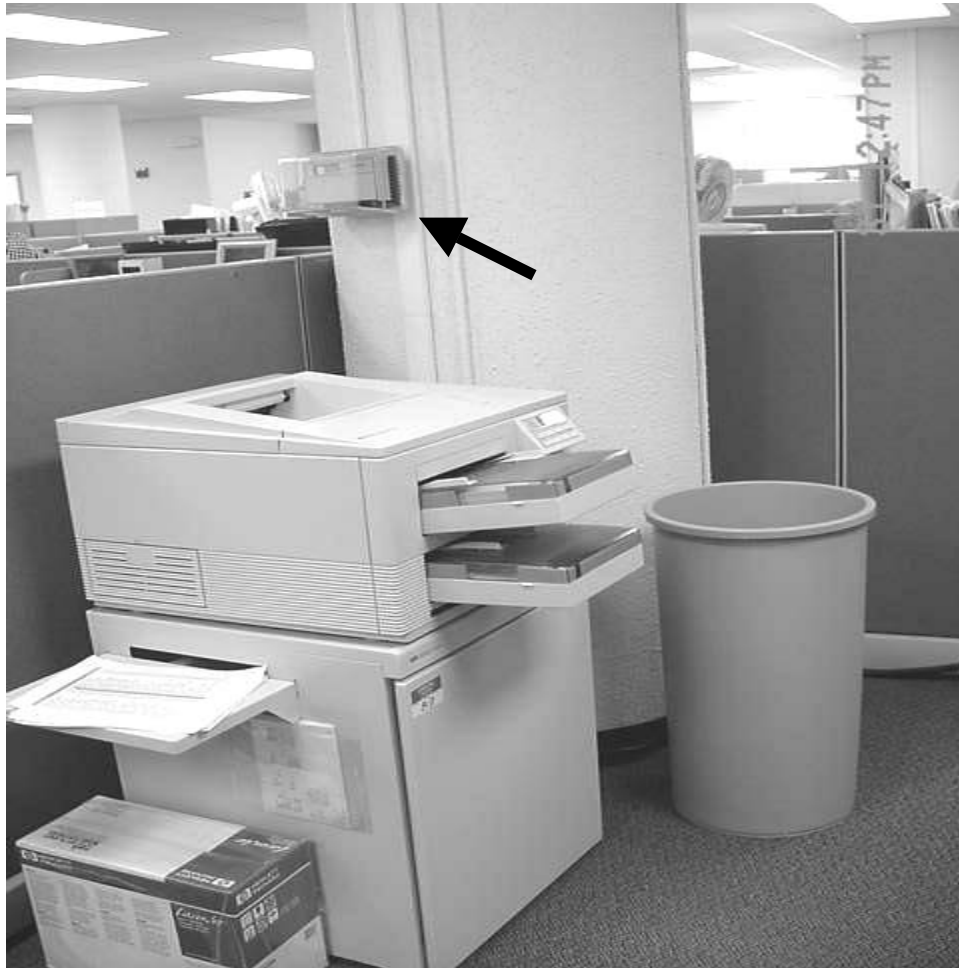
Picture 3

Thermostat Located Directly above Printer

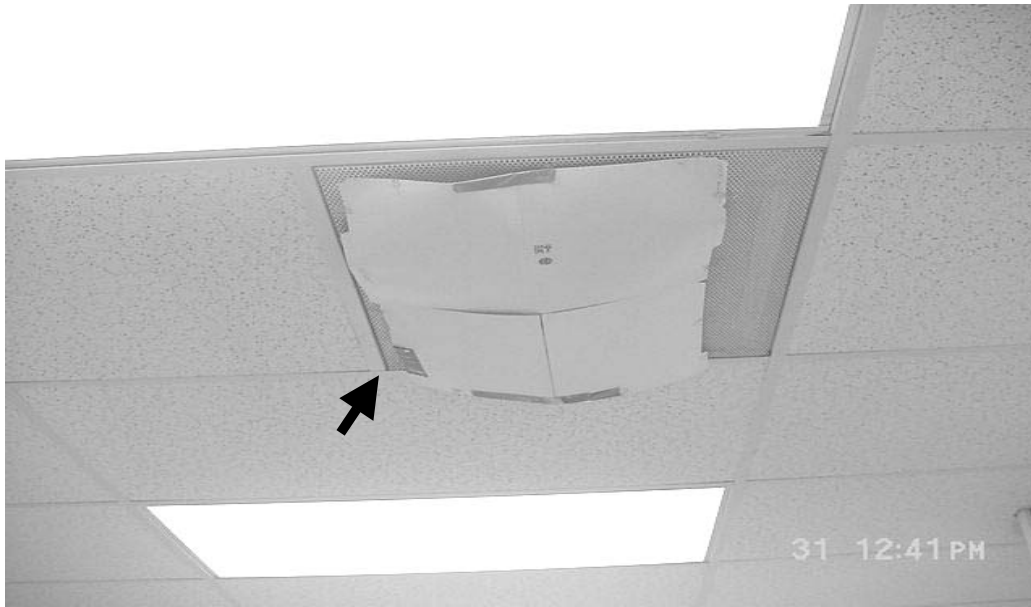
Picture 4

As mentioned previously, supply ductwork was not connected to air diffusers, which can allow air to bypass diffusers, forcing air directly on occupants seated below the air diffusers. In some areas air diffusers were blocked with masking tape and/or cardboard (see Picture 4) in an effort to control drafts. This alteration of the system, however, can throw the system off-balance and create uneven heating/cooling conditions in other areas adjacent to the blocked diffuser.

Air Diffuser Obstructed by Cardboard/Duct tape

7. Remove blockages from air diffusers (i.e. cardboard) to facilitate airflow.
8. Consider increasing the dust-spot efficiency of HVAC filters. Prior to any increase of filtration, each AHU should be evaluated by a ventilation engineer as to whether it can maintain function with more efficient filters.

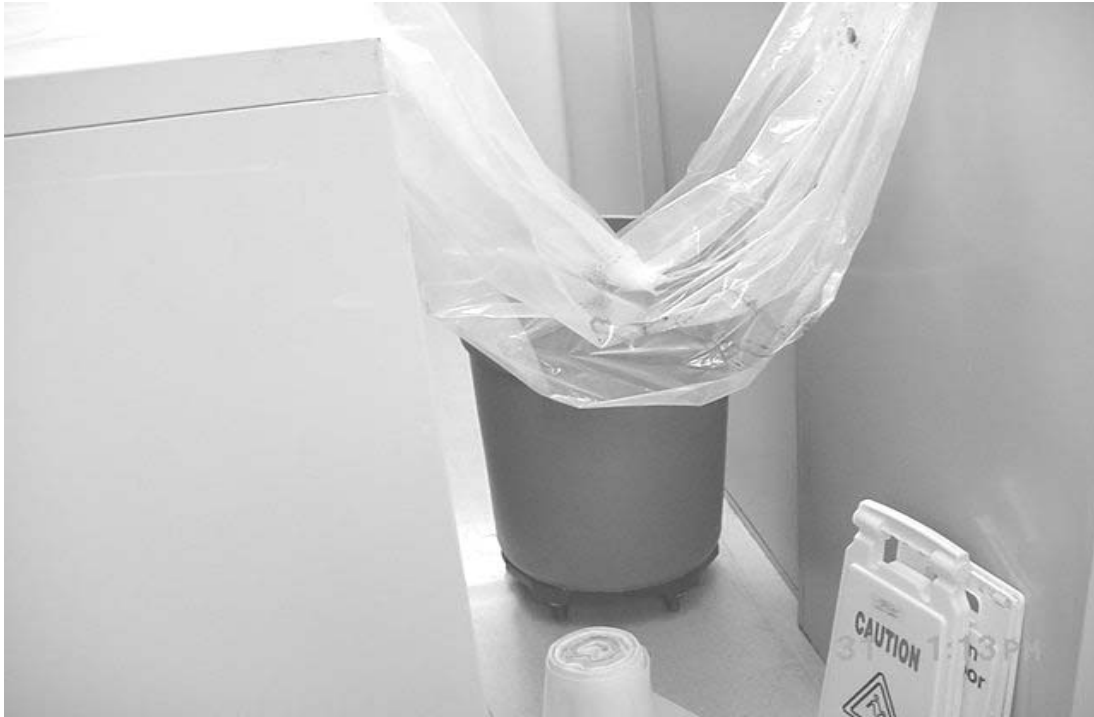
Picture 5

Stained ceiling tiles were observed in some areas. The file room appears to be an area of reoccurring water damage. DOR staff affixed plastic sheeting over boxes and records to protect them from water damage. Plastic sheeting was also configured in a manner to direct water into trash receptacles placed below areas of potential leaks (see Picture 5). Water-damaged ceiling tiles can be a medium for mold and mildew growth and should be replaced after a water leak is discovered. DOR staff reported water damaged ceiling tiles and ductwork insulation attributed to roof leaks. DOR staff indicated that main areas affected by water damage were the file room, areas 270, 275, 313 and above the ceiling plenum over the support column along the north wall of the office. On the day of the assessment, all areas of the ceiling plenum surveyed were dry. No signs of standing water, mold growth or unusual odors were detected, however the plenum above area 270, had missing/damaged ductwork insulation and uninsulated copper piping (see Pictures 6 & 7). When warm, moist air passes over a surface that is colder than the air; water condensation can collect on the cold surface. Under these

Plastic Sheeting Used to Direct Water Leaks into Trash Barrel in File Room

9. Report any roof leaks or other signs of water penetration to the building manager for prompt remediation.
10. Once roof leaks are under control, replace any remaining water-stained ceiling tiles. Examine the area above and beneath these tiles for mold growth. Disinfect

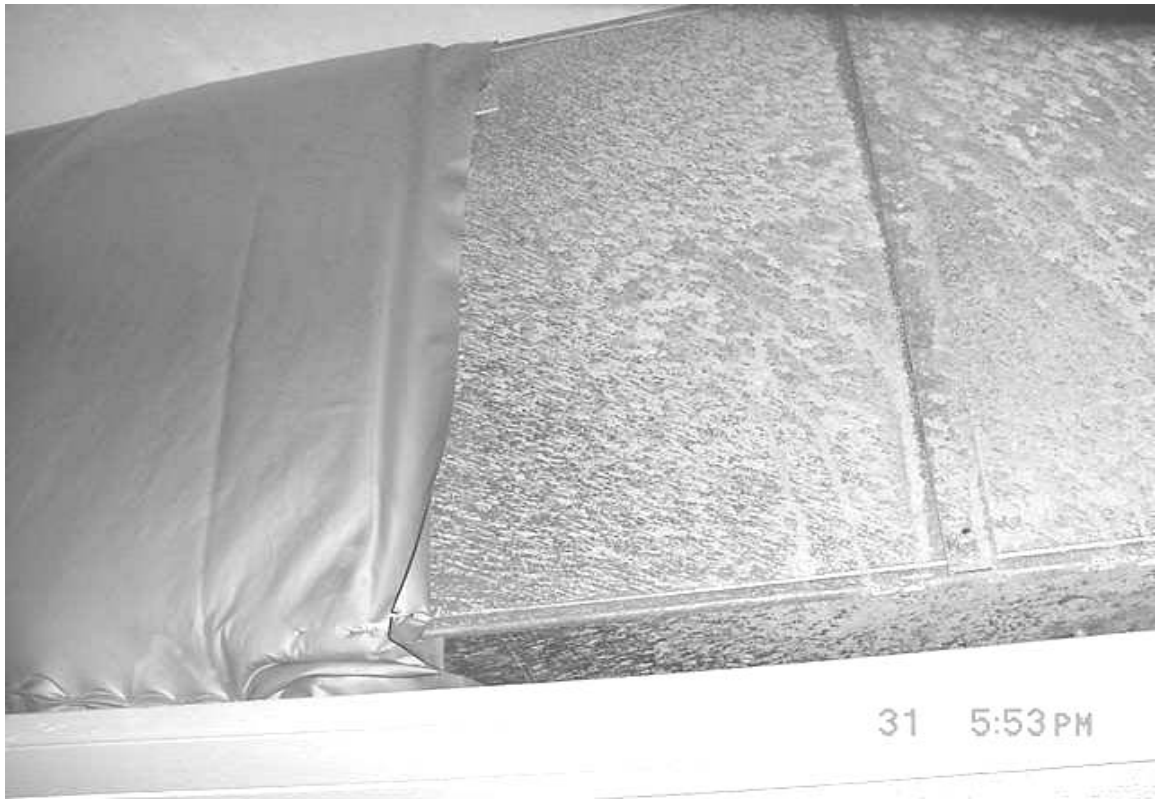
Picture 6

Partially Insulated Metal Ductwork Observed in the Ceiling Plenum

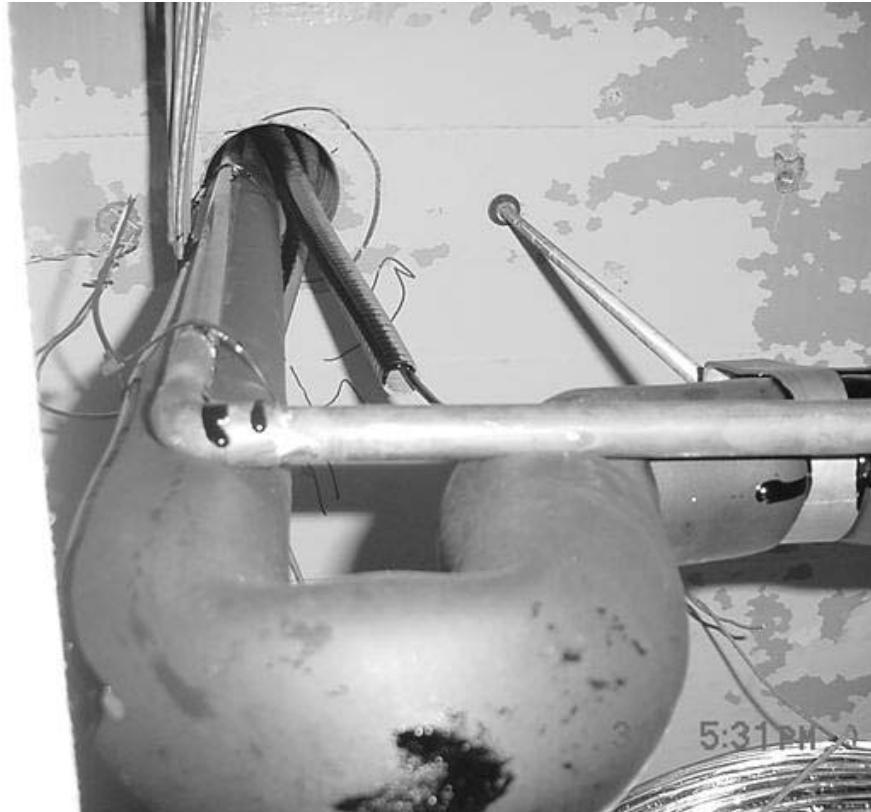
Picture 7

Uninsulated Copper Piping Observed in Ceiling Plenum

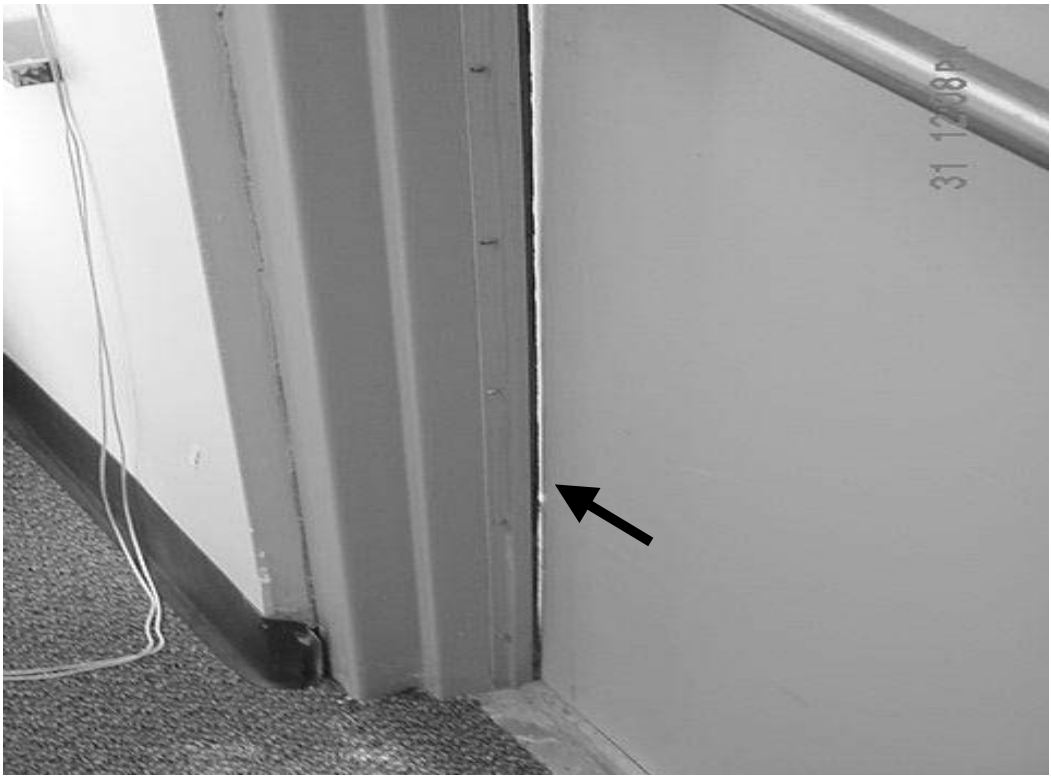
Picture 8

Spaces were noted around the second floor exterior door near the fire escape. Light could be seen penetrating through this space (see Picture 8) and drafts were noted. The floor around this door is carpeted. Depending on wind and weather conditions, rainwater can penetrate through this space and wet carpeting and wallboard. On the day of the assessment, water damaged wallboard was noted near the baseboard in this area (see Picture 9). In addition, a number of areas had water coolers on carpeting (see Picture 10). Spills from the water cooler can result in wetting of the carpet, which can lead to mold growth.

Space around Exterior Door on Second Floor: Note Light Penetration along Door

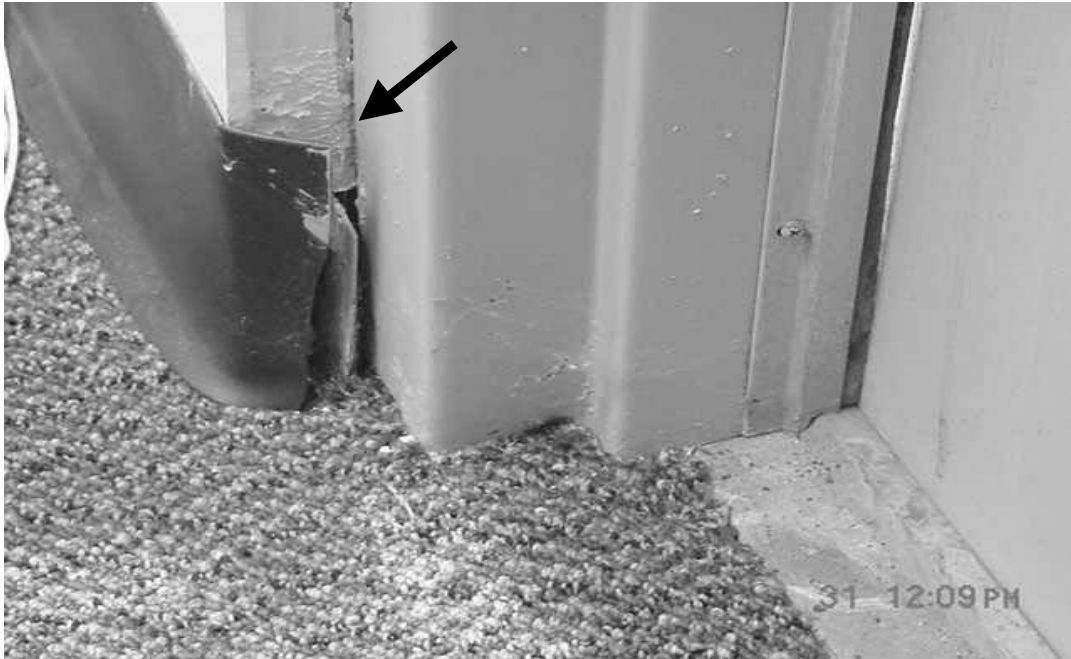
Picture 9

Water Damaged Wall near Exterior Door in Picture 8: Note Baseboard Pulling Away from Wall

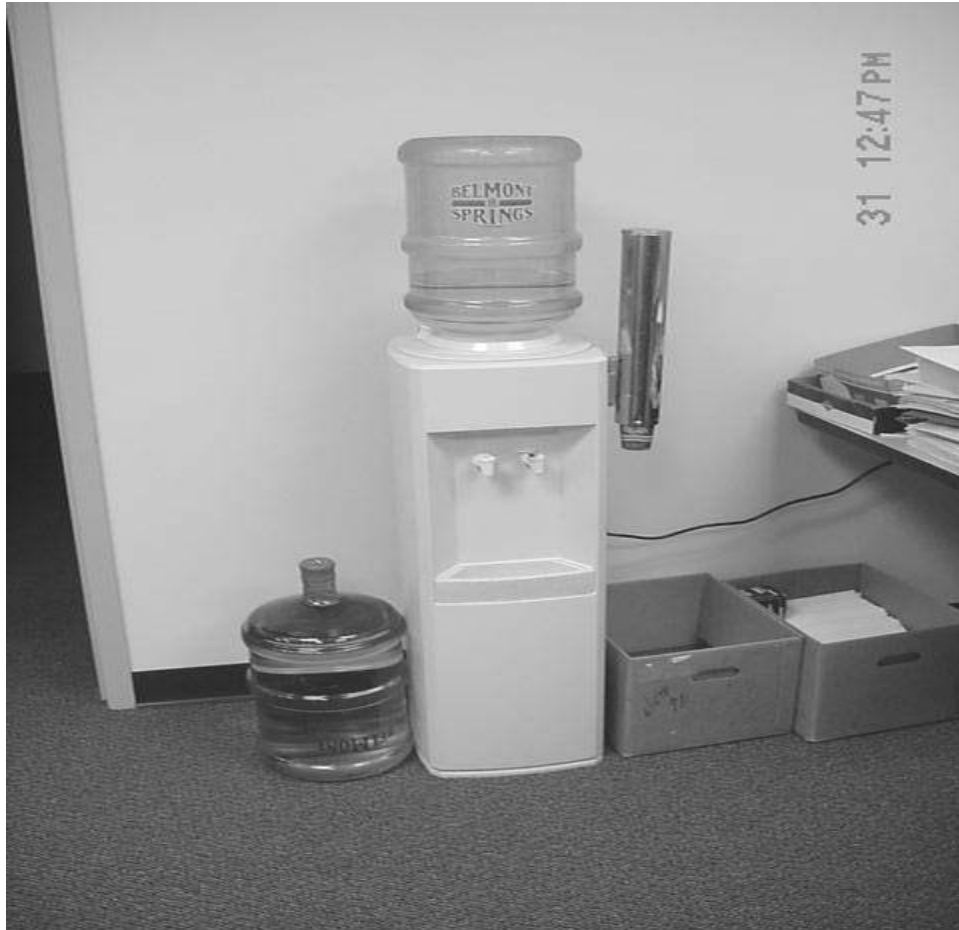
Picture 10

Water Cooler on Carpet

13. Relocate or place tile or rubber matting underneath water coolers in carpeted areas.
 14. Keep windows closed during hot, humid weather to maintain indoor temperatures and to avoid condensation problems.

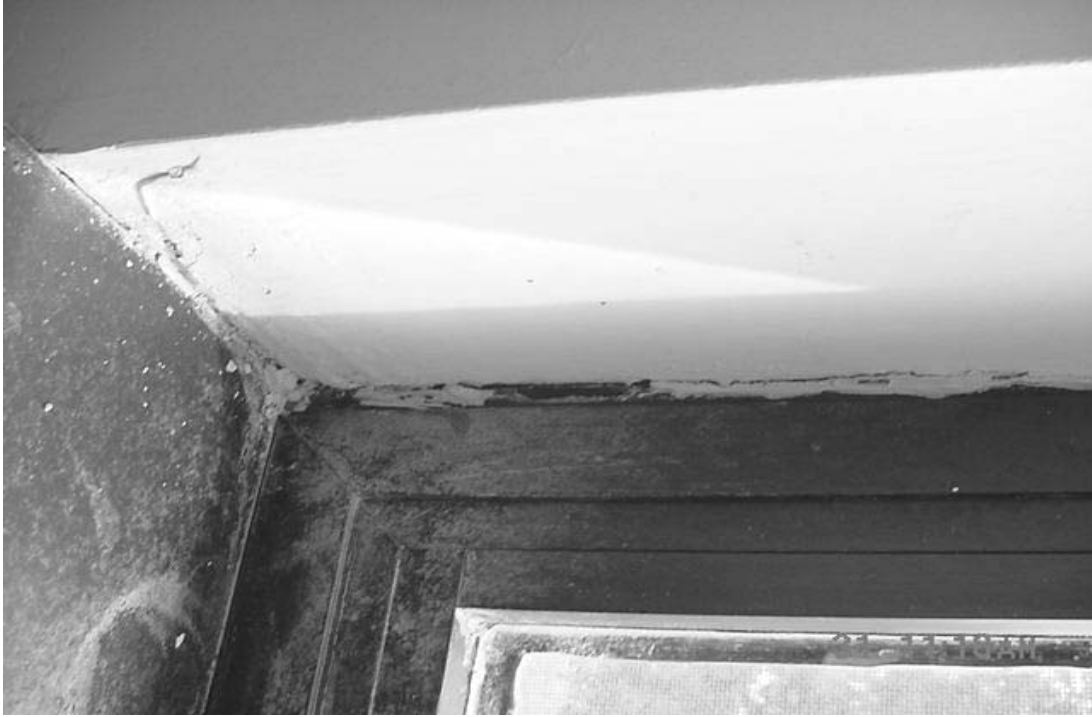
Picture 11

Water damaged wallboard was also noted around the windowsill in area 221 (see Picture 11). Like other porous materials, if gypsum wallboard becomes wet repeatedly it can provide a medium for mold growth and is difficult to clean at best.

Water Damage around Window

- areas of water leaks with an appropriate antimicrobial. Clean areas of antimicrobial application when dry.
11. Replace missing or damaged caulking and check seals on double-paned windows to prevent water penetration and potential mold growth. Once sources of water penetration are remedied, repair/replace water damaged wallboard/windowsills.

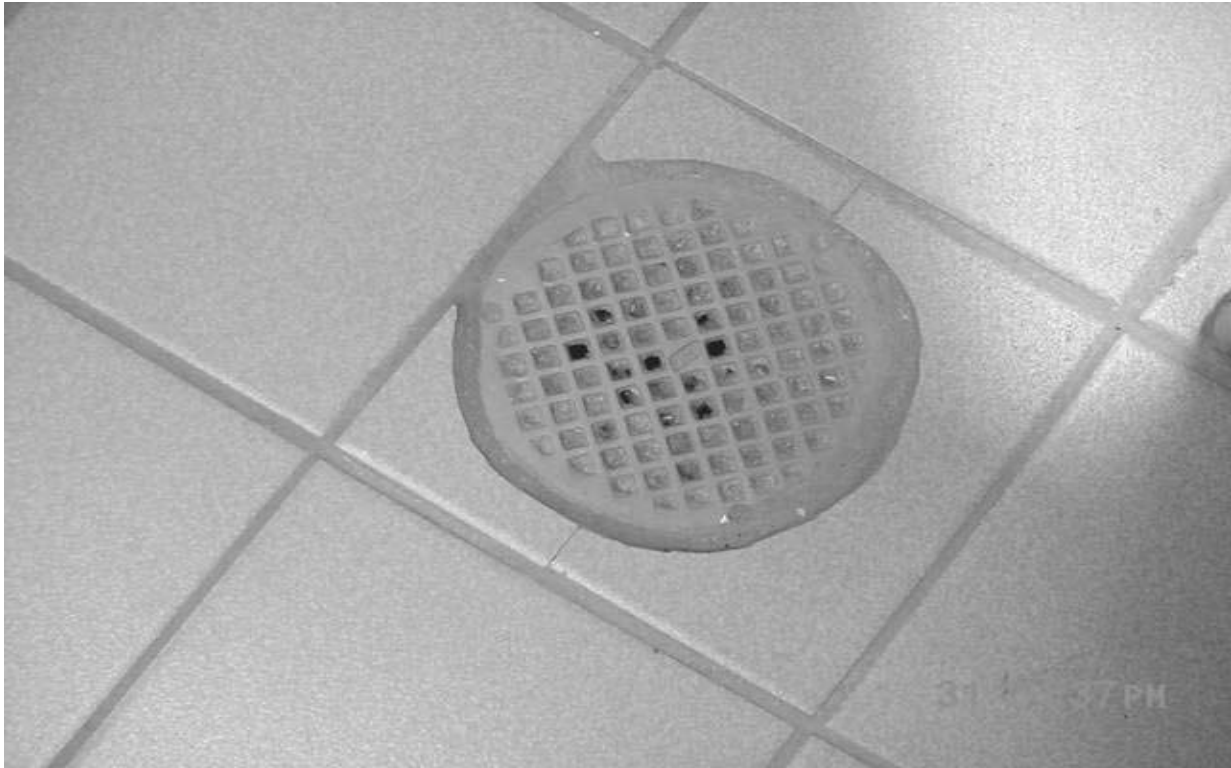
Picture 12

Several other conditions that can potentially affect indoor air quality were also identified. Floor drains were noted in restrooms. Drains are designed with traps in order to prevent sewer odors/gases from penetrating into occupied spaces. When water enters a drain, the trap fills and forms a watertight seal. Without periodic input of water (e.g., every other day), traps can dry and compromise the integrity of the watertight seal. If traps dry out, sewer odors/gases can travel up the drain into occupied areas. The drain in the woman's restroom was clogged with debris and could not be checked properly (see Picture 12).

Clogged Floor Drain in Woman's Restroom

19. Ensure water is poured into floor drains regularly to maintain the integrity of the traps.
20. Use IPM to remove pests from the building. A copy of the IPM recommendations is included with this report as Appendix A (MDFA, 1996). Activities that can be used to eliminate pest infestation may include the following activities.

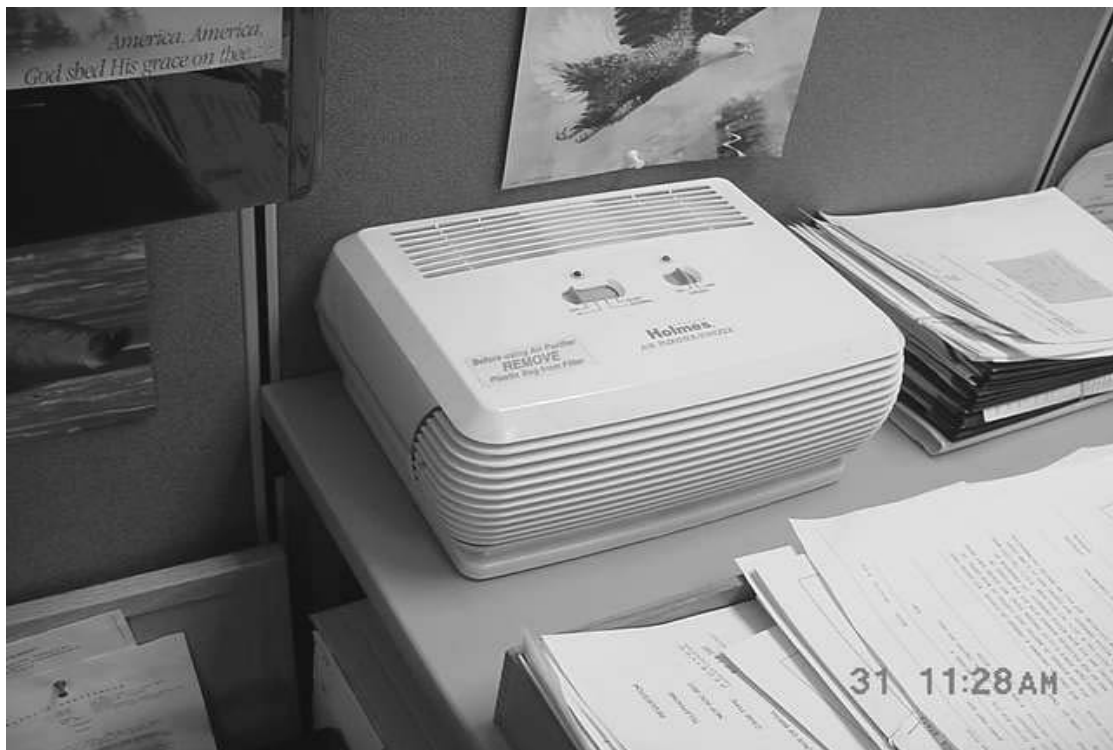
Picture 13

A personal air filtration unit was noted in one employee's work area (see Picture 13). These units are equipped with a filter, which should be cleaned/replaced as per the manufacturer's instructions. If not properly maintained, filters can become saturated and re-aerosolize dirt, dust and particulate matter.

Personal Air Filtration Unit

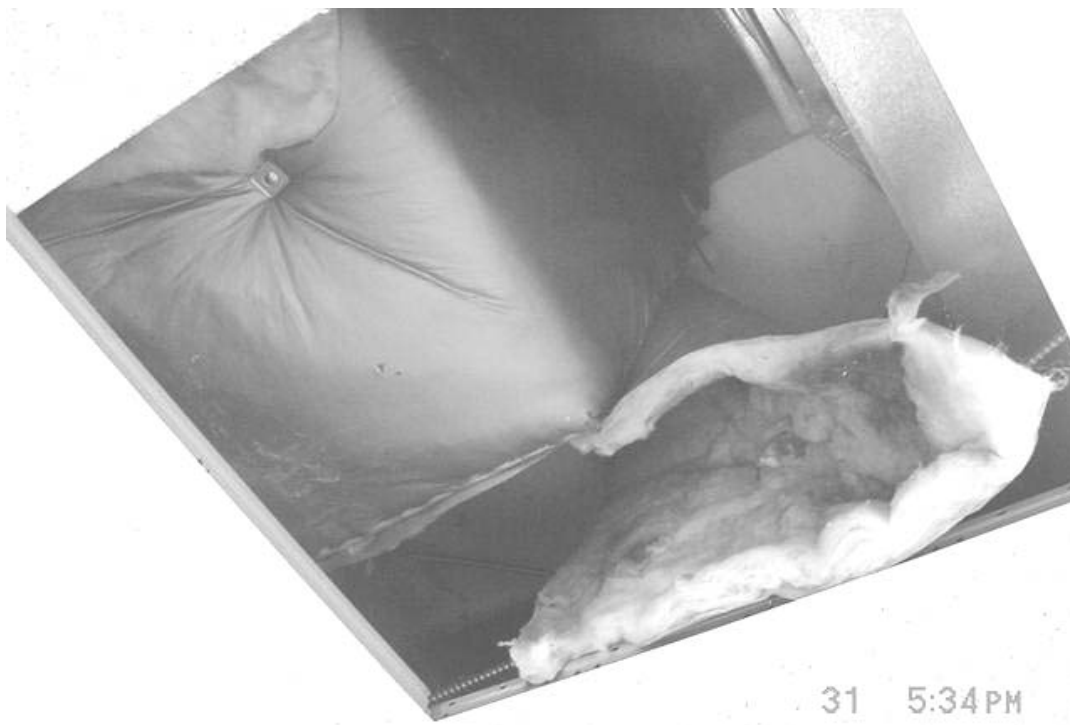
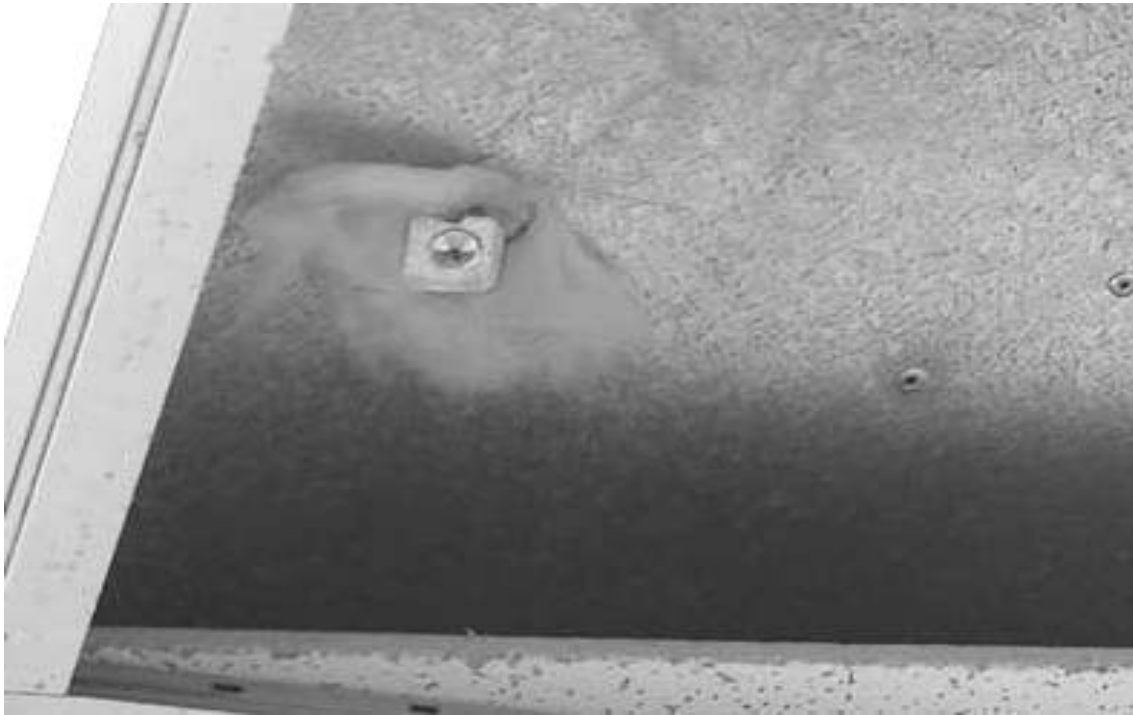
As previously mentioned, the building has a history of roof leaks. Subsequent to the roof leaks, fiberglass insulation around ductwork was damaged and in some places removed or re-wrapped (see Pictures 14 & 15). A number of ceiling tiles were reportedly changed throughout the office. The condition of damaged fiberglass insulation around

ductwork in the ceiling plenum coupled with the movement and replacement of ceiling tiles provides the opportunity for airborne dirt, dust and particulates to penetrate into occupied areas. Aerosolized dust, particulates and fiberglass can provide a source of eye, skin and respiratory irritation to certain individuals. In addition, these materials can accumulate on flat surfaces (e.g. desktops, shelving, carpets, etc.) below these areas and subsequently be re-aerosolized causing further irritation.

Damaged Fiberglass Insulation above Ceiling Tiles

**Area above Ceiling tiles where Insulation has been Removed from Ductwork,
Note Fastener which held on Insulation**

16. Examine fiberglass insulation around ductwork for mold colonization in areas that have or have had roof leaks on the second floor. If moldy, replace these materials and disinfect non-porous surfaces with an appropriate antimicrobial agent.

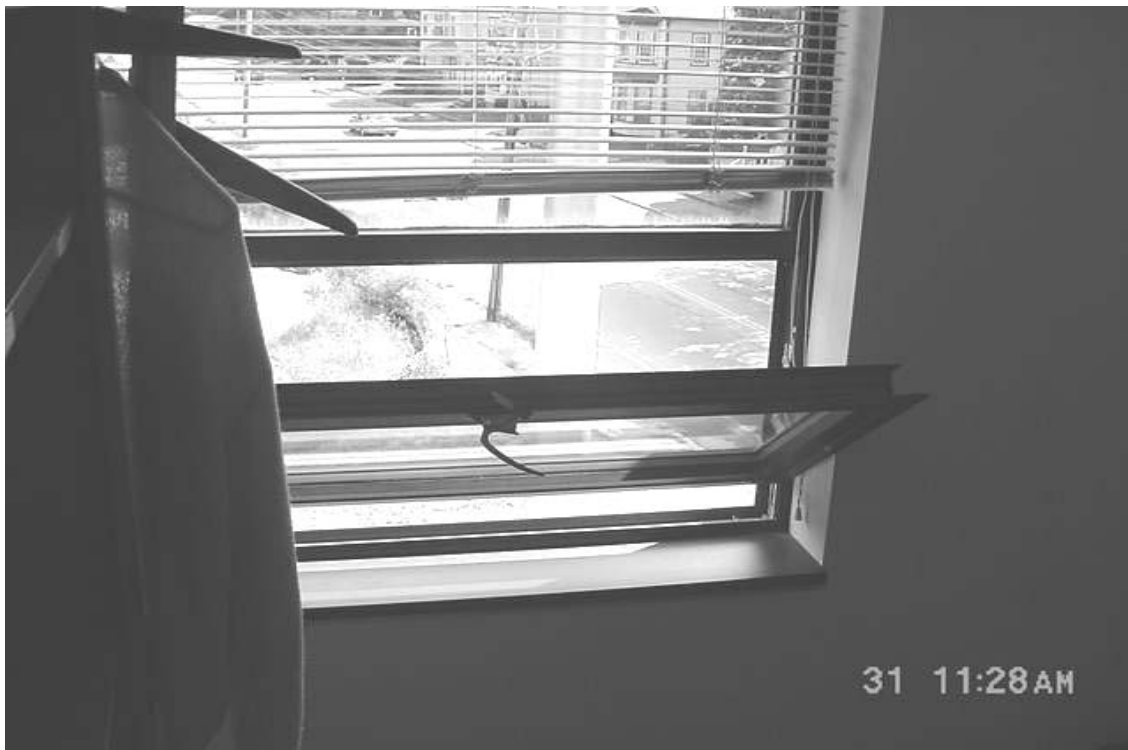
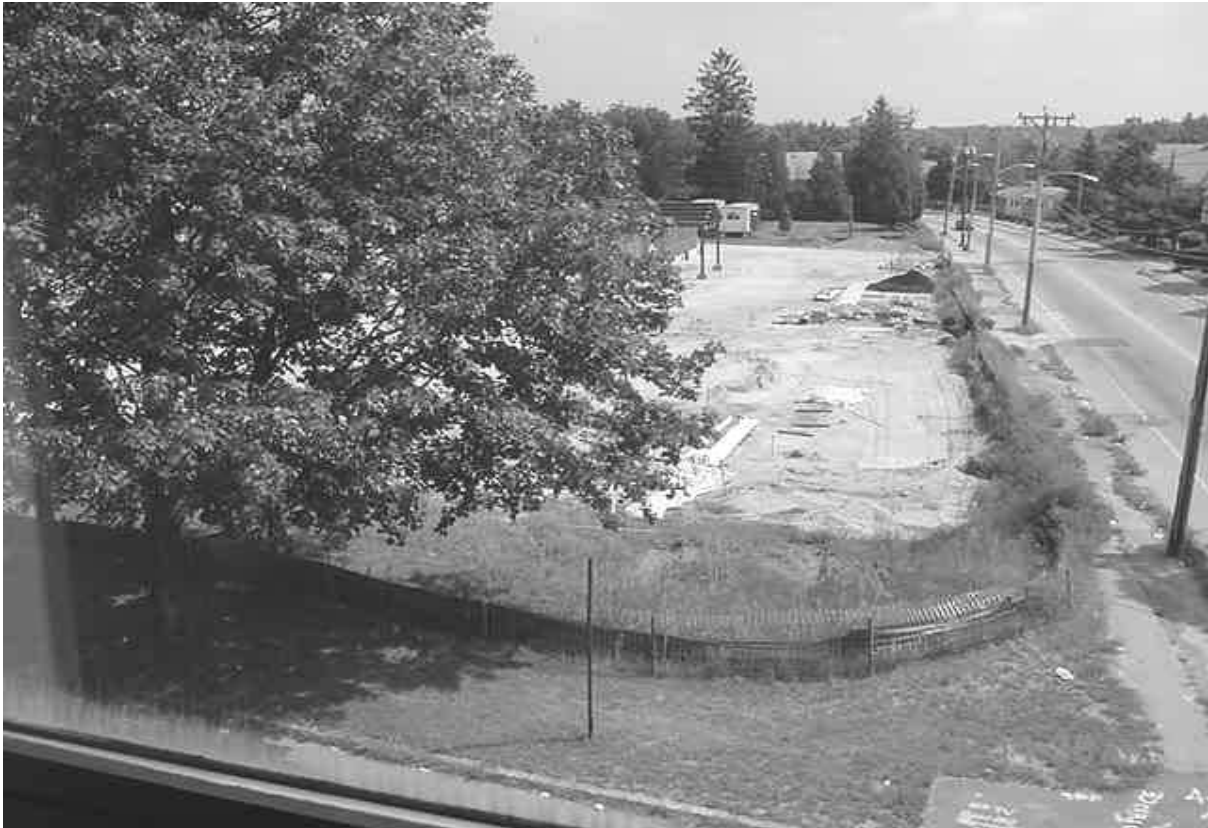
Another pathway of particulates into occupied areas is through open windows. A construction project is being conducted on the property adjacent to the DOR building (see Pictures 16 & 17). Construction vehicles can aerosolize large amounts of dirt, dust and other particulates. The open windows allow unfiltered outdoor air to enter the indoor environment that may transport airborne dirt, dust and particulates. Operating construction vehicles can also result in the entrainment of vehicle exhaust into the building, which may, in turn, provide opportunities for exposure to compounds such as carbon monoxide.

Opened Window in Area Adjacent to Construction Zone

Construction Area Adjacent to 10 Mulberry Street

12. Close windows adjacent to outdoor construction activities generating dusts and/or odors.

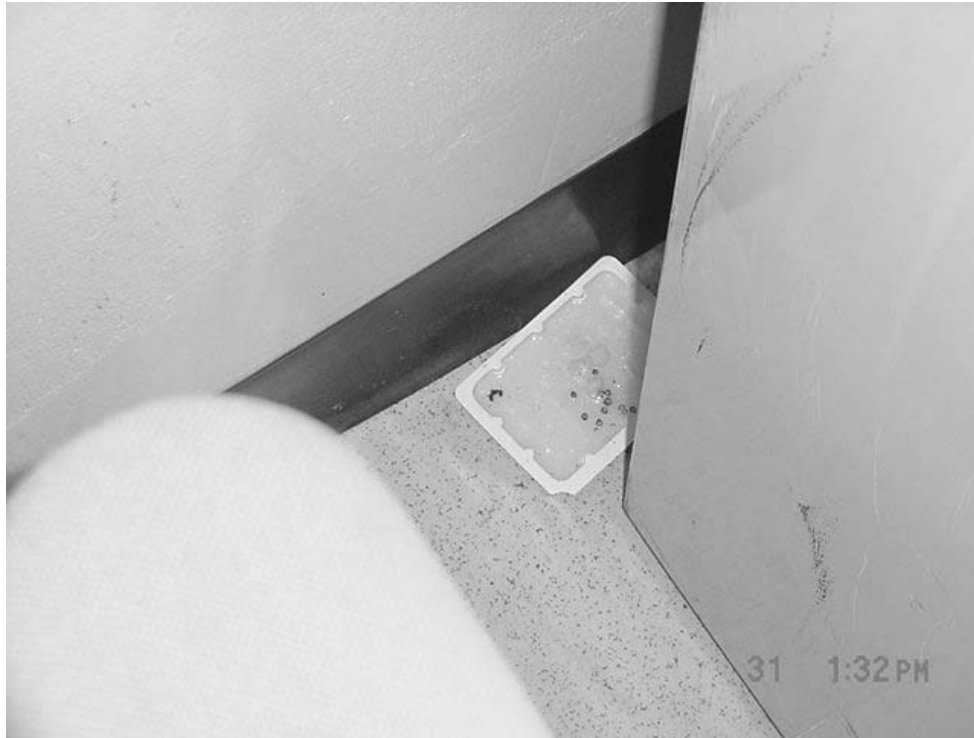
Picture 18

The building has also had a problem with pests (see Picture 18). The OccuHealth Report found elevated levels of insect parts in air samples (OccuHealth, 2000). Insect parts can become dried out and aerosolized and may serve as a source of allergenic material for certain sensitive individuals. Under current Massachusetts law that will go into effect November 1, 2001, the principles of integrated pest management (IPM) must be used to remove pests in state buildings (Mass Act, 2000). A copy of the IPM guide is attached as Appendix A.

Insect Trap Noted in Breakroom Behind Refrigerator

- i) Consult a licensed pesticide applicator on the most appropriate method to end infestation.
 - ii) Reduce/eliminate pathways/food sources that are attracting rodents.

- iii) Reduce harborages (cardboard boxes) where pests may reside.

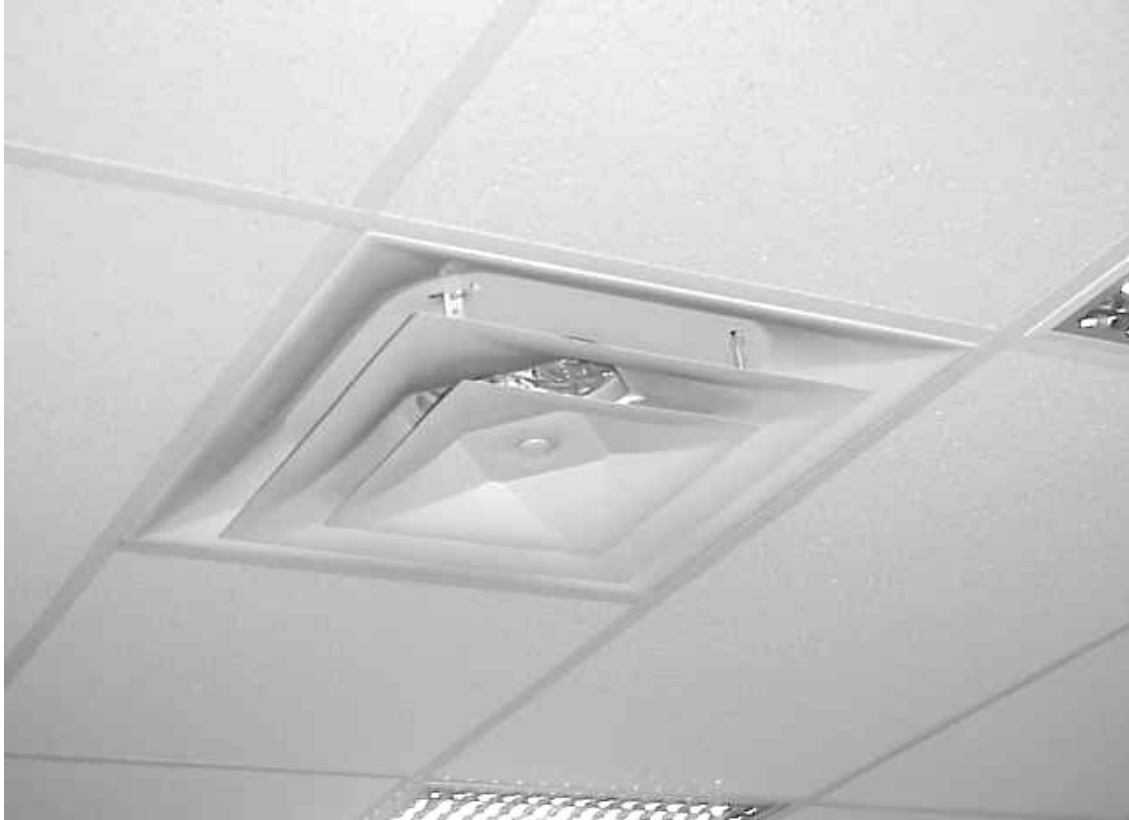
Picture 19

**Example of Multi-Directional Air Diffuser
Attached Directly to Ductwork “Closed” System**
